STATE OF ILLINOIS  
DEPARTMENT OF TRANSPORTATION

EXISTING BOX CULVERT REPAIR DETAILS  
STRUCTURE NUMBER 042-2475

SHEET NO. 5 OF 5 SHEETS

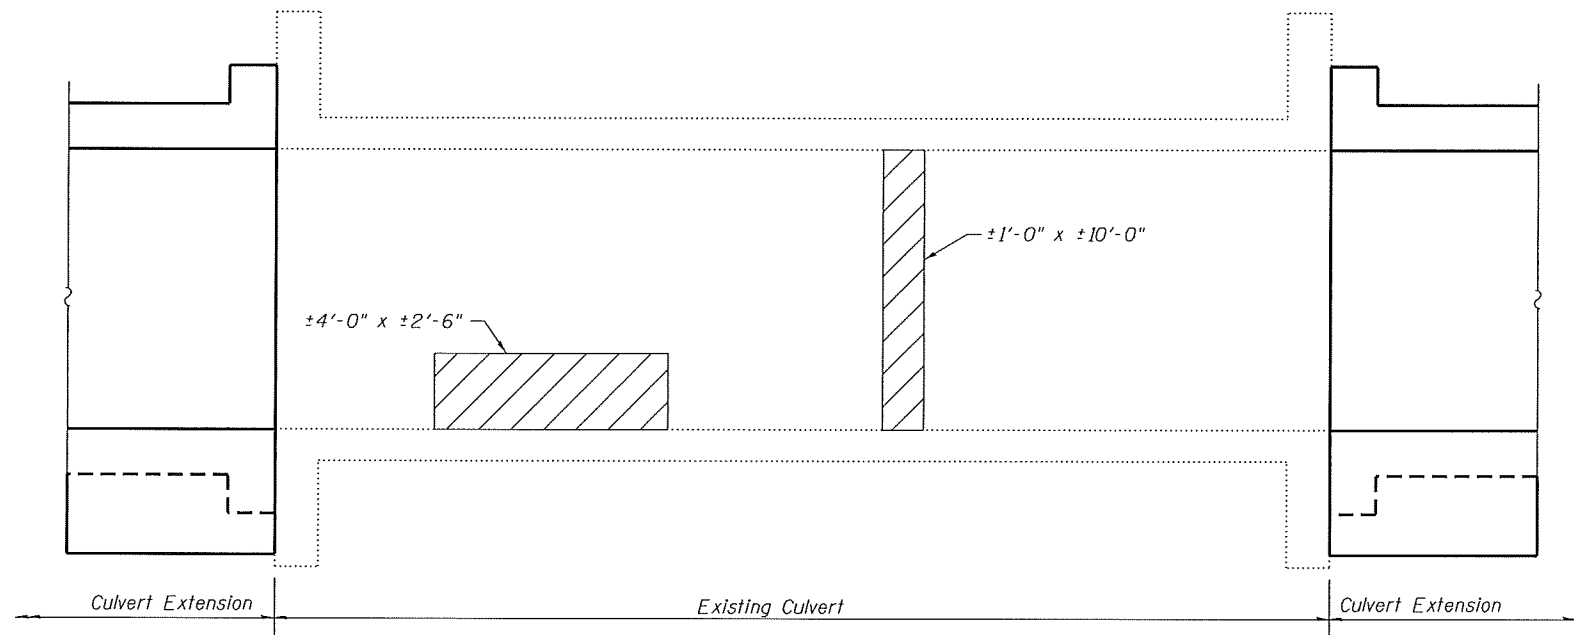
**ELEVATION**  
(Showing Inside Face of East Wall)

Indicates Limits of Structural Repair of Concrete
