STATE OF ILLINOIS
DEPARTMENT OF TRANSPORTATION

DRAINAGE REPAIR DETAILS							
S.N. 082-6001	MLK	BRIDGE	OVER	MISSISSIPPI	RIVER		
	SHEET	NO. \$128 O	F \$138	SHEETS

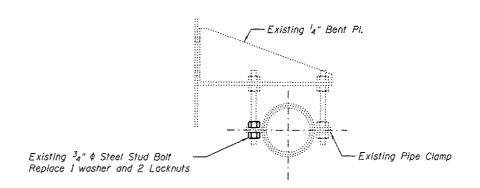
BROKEN DRAIN

I LOOSE BOLT IN DRAIN CONNECTION

## MISSING FASTENER ON DRAIN PIPE SUPPORT

NBIS Item #	Span	Location	Deficiency	Repair
72	4	Midspan at Girder 4	Broken Hanger	Replace Hanger
72	9	Pan. 3, N. Side	Broken Hanger	Replace Hanger
72	9	Pan. 6, N. Side	Broken Hanger	Replace Hanger
72	9	Pan. 8, N. & S. Side	Broken Hanger	Replace Hanger
100	W	Under Stringer 5 at Bent W	Missing Fastener on Drain Pipe Support	Replace Fastener
144	9	Between L7 & L8, N. Side	Drain Downspout Misaligned	Realign Downspout
<i>30</i> 5	31, 32	North Column of Bent 31	Drain Pipe is Disconnected	Reconnect Drain Pipe
<i>305</i>	31, 32	North Column of Bent 31	Clogged, Full of Debris	*Unclog Drain
309	4	20' from Bent 3 at Girder 1	Broken Drain	Reconnect Drain Pipe
368	W	Throughout South Side	Clogged, Full of Debris	*Unclog Drain
369	1, 2	North Column, 6' from Ground Level	1 Loose Bolt in Drain Connection	Tighten Bolt
<i>372</i>	9	Throughout South Side	Clogged, Full of Debris	*Unclog Drain

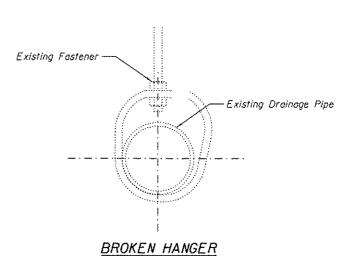
DRAIN DOWNSPOUT MISALIGNED

DRAIN PIPE DISCONNECTED
