STATE OF ILLINOIS DEPARTMENT OF TRANSPORTATION

ABUTMENT CONCRETE REPAIR STRUCTURE NO. 016-0372

SHEET NO. 5

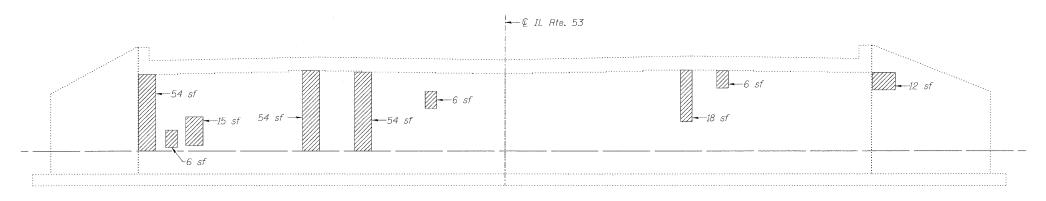
NORTH ABUTMENT ELEVATION

(Looking North)

Repair of the existing abutments shall include but may not be limited to the areas shown. The actual areas to be repaired will be determined by the Engineer at the time of construction.

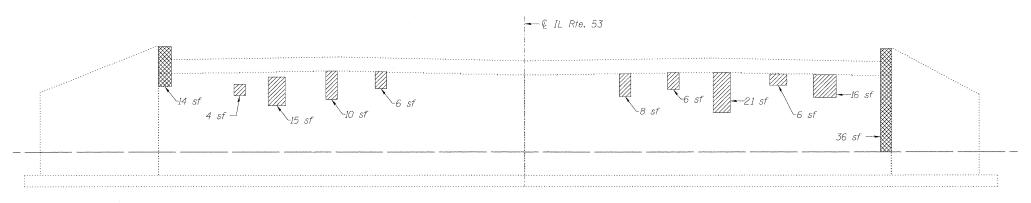
SOUTH ABUTMENT ELEVATION

(Looking South)
