PIER
BILL OF MATERIAL

Inspection Date: 12/11/07

PIER
OLD IL 13 OVER BANKSTON FORK
FAS ROUTE 899 - SECTION 8BR-2
SALINE COUNTY
STATION 802+60.00
STRUCTURE NO. 083-0036

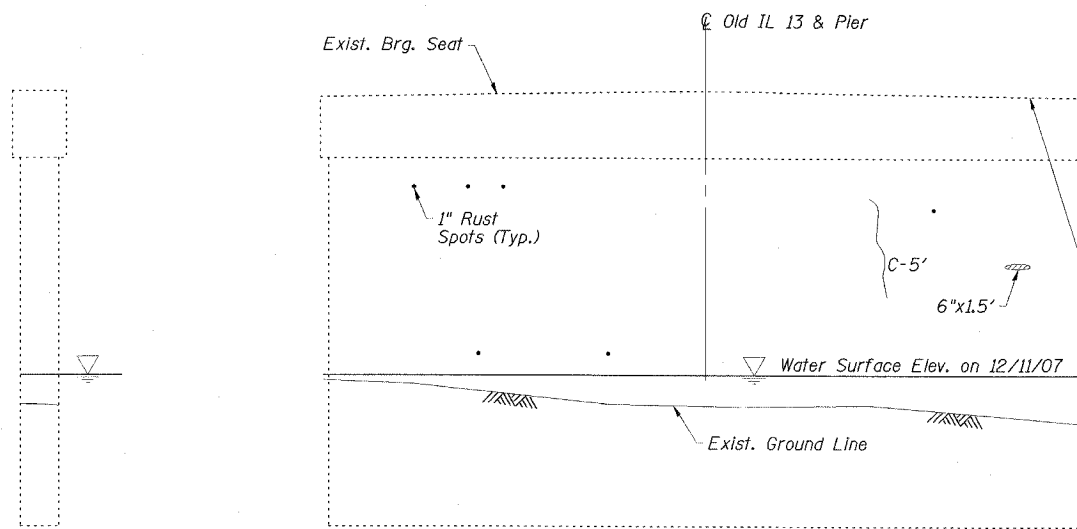
EAST ELEVATION

C-6' Crack to be epoxy injected
-

Delaminated or Spalled Area - Use Structural Repair of Concrete
-

Rust Spot

EXISTING BEARING SEAT TO BE INSPECTED BY THE ENGINEER AFTER DECK BEAM REMOVAL. DETERIORATED CONCRETE AREAS SHALL BE REPAIRED (ESTIMATED 15 S.F. STRUCTURAL REPAIR OF CONCRETE DEPTH < 5") AND CRACKS SHALL BE SEALED (ESTIMATED 20' EPOXY CRACK INJECTION) IF FOUND. CONCRETE SEALER SHALL BE APPLIED TO CONCRETE REPAIR AREAS.

NOTE: PIER CRACK REPAIR LENGTHS AND STRUCTURAL REPAIR OF CONCRETE AREAS ARE ESTIMATED FROM 12-11-07 SURVEY WORK. ACTUAL LOCATIONS AND QUANTITIES OF REPAIRS SHALL BE SHOWN BY THE ENGINEER ON THE AS-BUILT PLANS FOR THIS SECTION.
