DECK PATCHING SURVEY
TRUSS SPANS

EXISTING S.N. 050-0088
IL 178 OVER ILLINOIS RIVER

LASALLE COUNTY

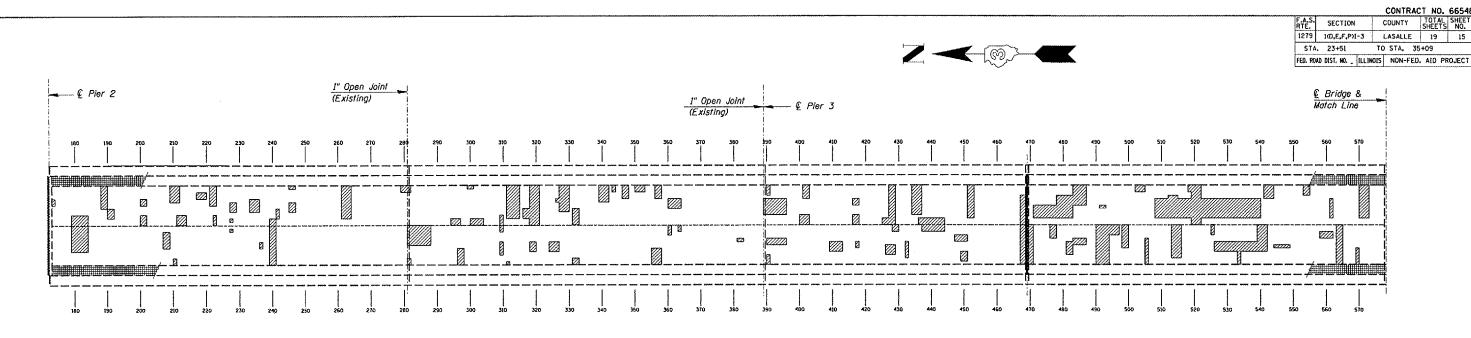
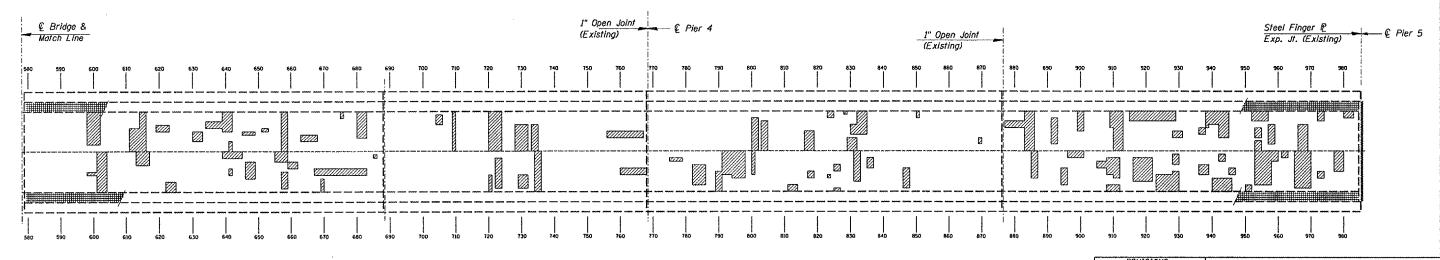
Hatched areas represent delaminated areas.

Deck Slab Repair (Partial) has been estimated at 19% of total deck area = 635 square yards.

Deck Slab Repair (Full Depth) has been estimated at 2% of total deck area = 70 square yards.

Date of Deck Survey: 12/28/04

The Engineer shall sound the entire deck surface to determine exact locations and quantities of "Deck Slab Repair".

The Engineer shall record the actual locations of the deck slab repair on the "As-Built" plans.
