STATE OF ILLINOIS
DEPARTMENT OF TRANSPORTATION

F.A.I. RTE.	SECTION	COUNTY	TOTAL SHEETS	SHEET NO.
64	82-7RS-1, 82-7HB-1, 2I	ST. CLAIR	89	71
FED. ROAD DIST. NO.	ILLINOIS FED. AID PROJECT		CONTRACT NO. 76813

DECK PLAN
N. MAIN STREET (FAS 844) OVER
INTERSTATE 64
F.A.I. 64 SEC. 82-7RS-1, 82-7HB-1, 2I
ST. CLAIR COUNTY
STATION 883+53.16
STRUCTURE NO. 082-0182

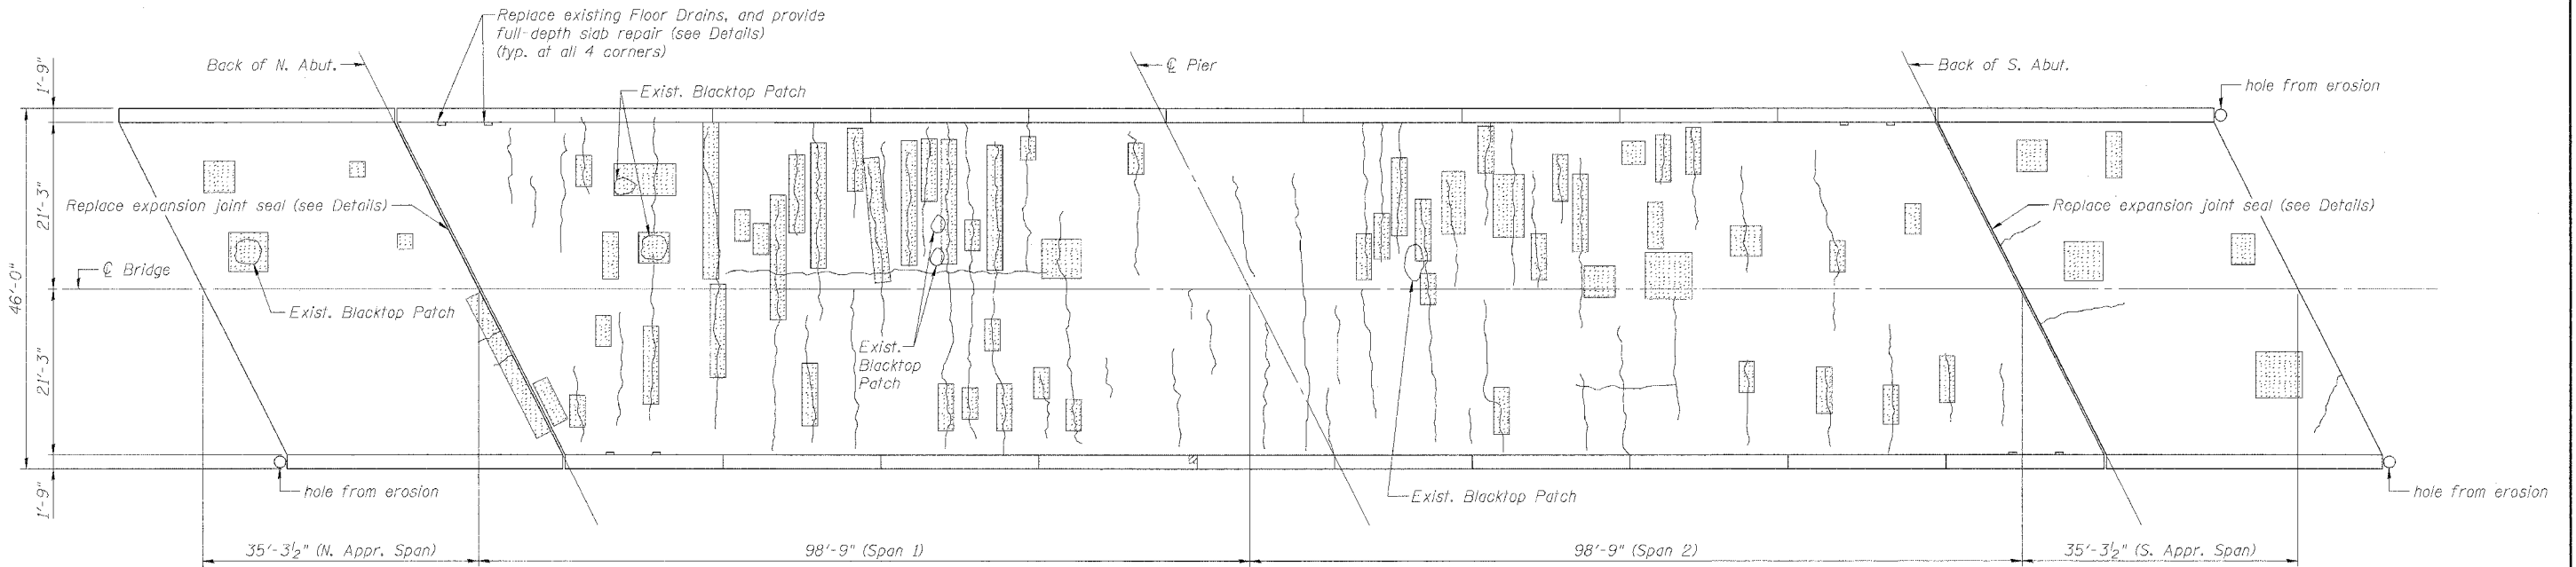
TOP PLAN

Hollow or Unsound Concrete (1120 S.F.)
-

Spalled Concrete (29 S.F.)
-

Spalled Concrete with Exposed Rebar (39 S.F.)
-

Hairline Crack

Deck Condition Survey performed 9/02/2004.
The Engineer shall record actual locations of deck repair on the As-Built plans.
