BITUMINOUS CRACK REPAIR - METHOD A DETAIL  
CONNECTING TAXIWAYS 1 AND 3  
N.T.S.

BITUMINOUS CRACK REPAIR - METHOD B DETAIL  
CONNECTING TAXIWAYS 2 AND 4  
N.T.S.

BITUMINOUS CRACK REPAIR - METHOD C DETAIL  
N.T.S.

PEKIN MUNICIPAL AIRPORT  
 PEKIN, TAZEWELL COUNTY, ILLINOIS  
 REHABILITATE AND MARK THE PARALLEL TAXIWAY  
 TYPICAL SECTIONS SHEET 2

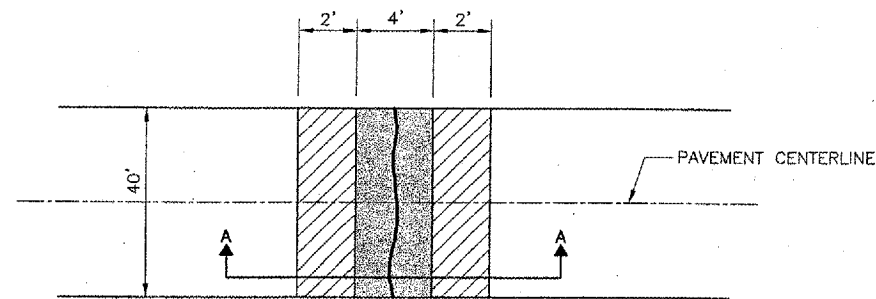
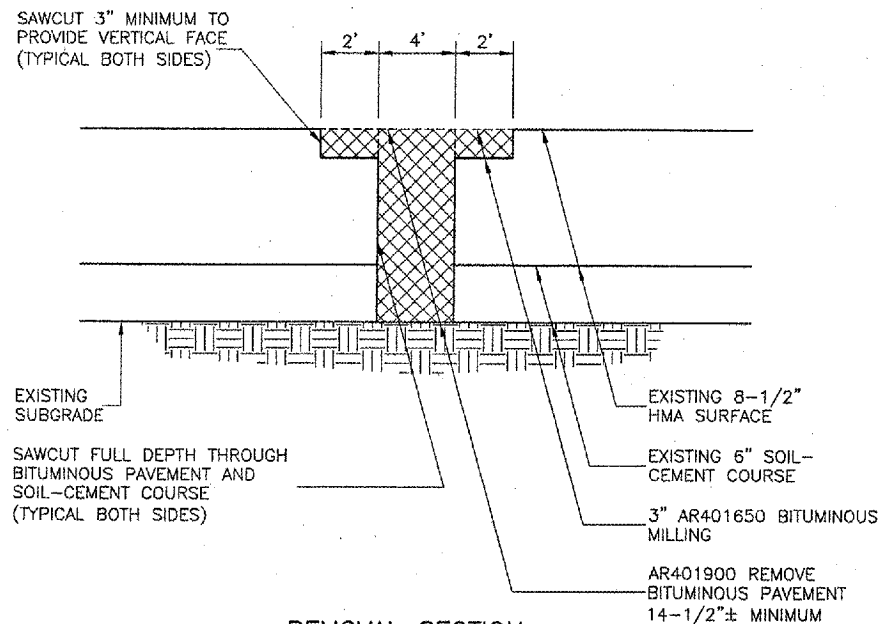
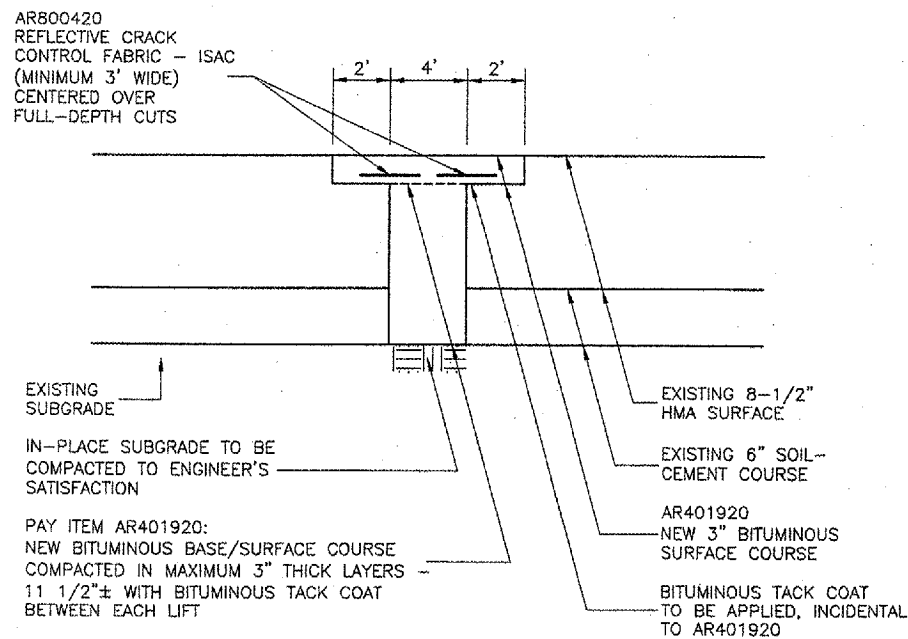
PLAN VIEW  
N.T.S.

REMOVAL SECTION  
N.T.S.

REPLACEMENT SECTION  
N.T.S.

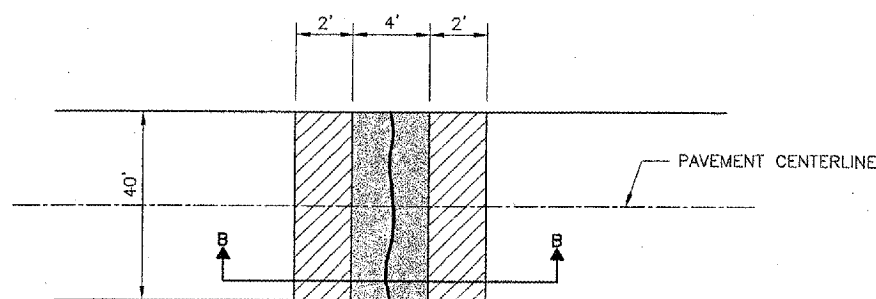
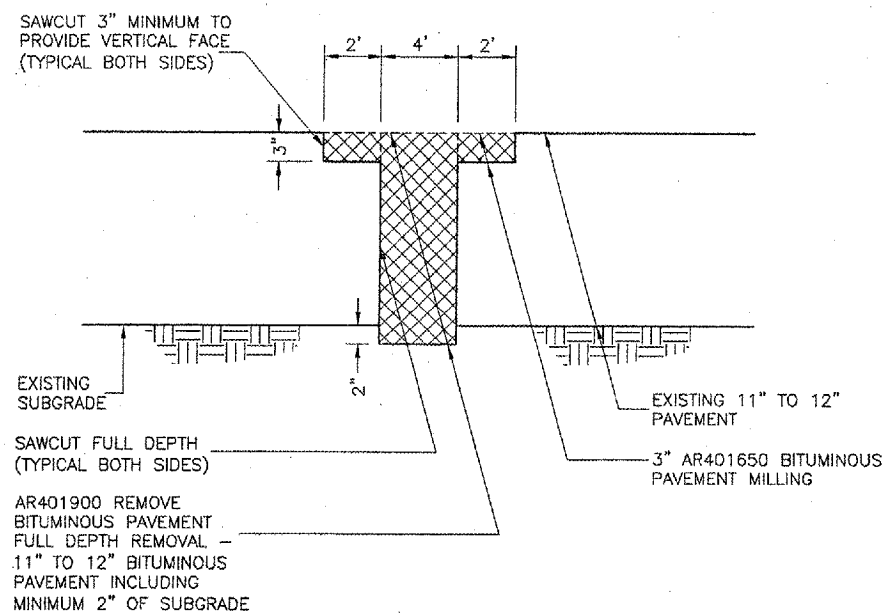
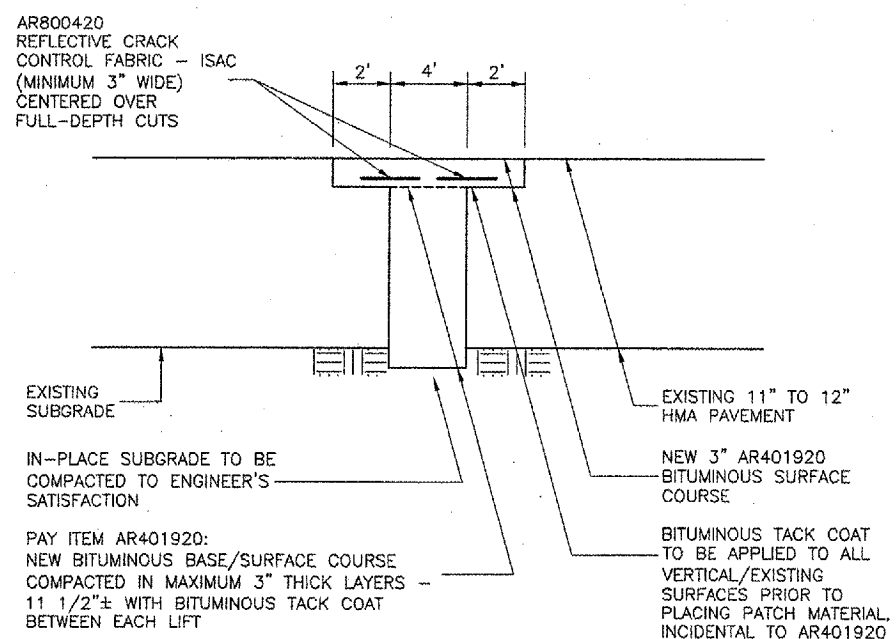
PLAN VIEW  
N.T.S.

REMOVAL SECTION  
N.T.S.

REPLACEMENT SECTION  
N.T.S.

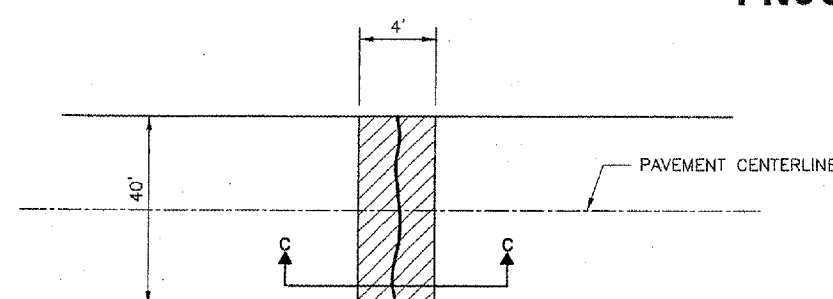
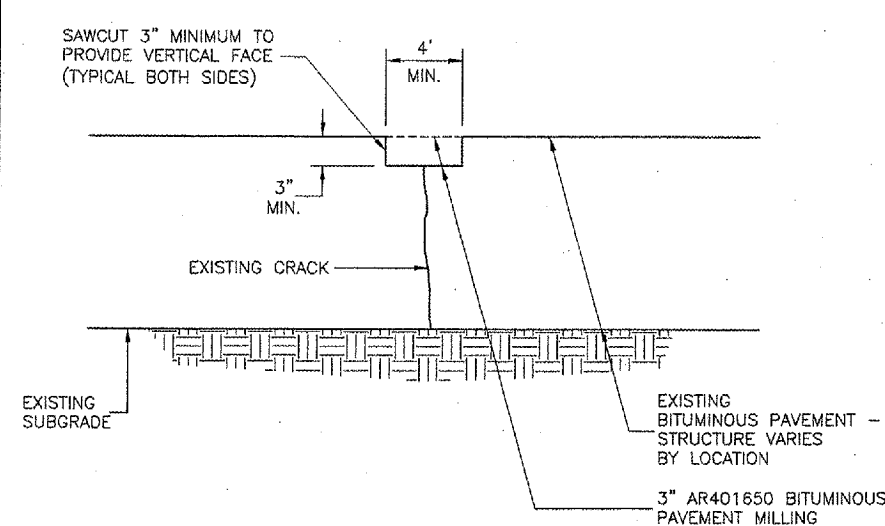
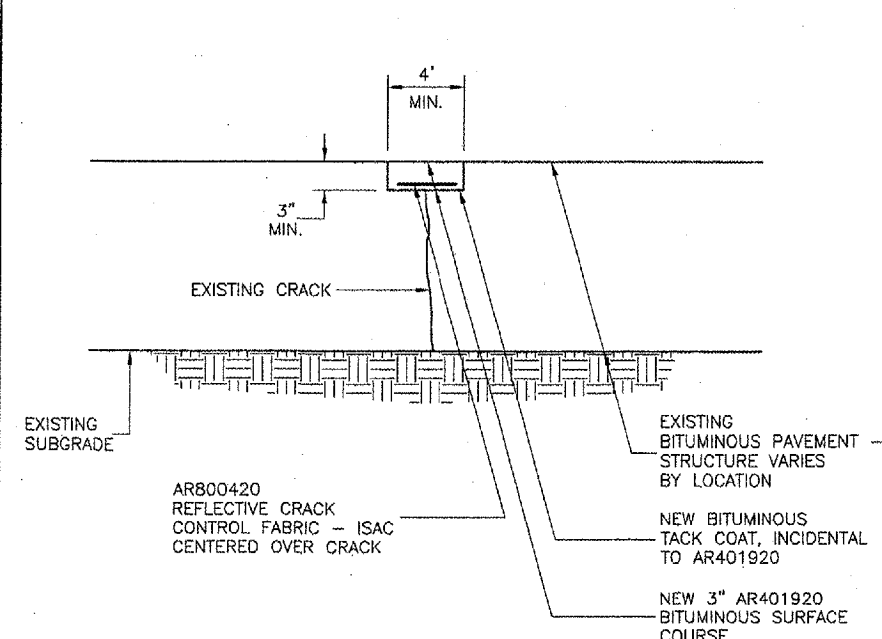
PLAN VIEW  
N.T.S.

REMOVAL SECTION  
N.T.S.

REPLACEMENT SECTION  
N.T.S.
